Naugatuck Rubber Factories Complex (U.S. Rubber)
Bounded on the north by Cedar Street, on the east
by Water Street and the Amtrak right-of-way, on the
south by the Amtrak right-of-way, on the west by
Church and Elm Streets
Naugatuck
New Haven County
Connecticut

HAER No. CT-21

WRITTEN HISTORICAL AND DESCRIPTIVE DATA

NAUGATUCK RUBBER FACTORIES COMPLEX (U.S. Rubber)

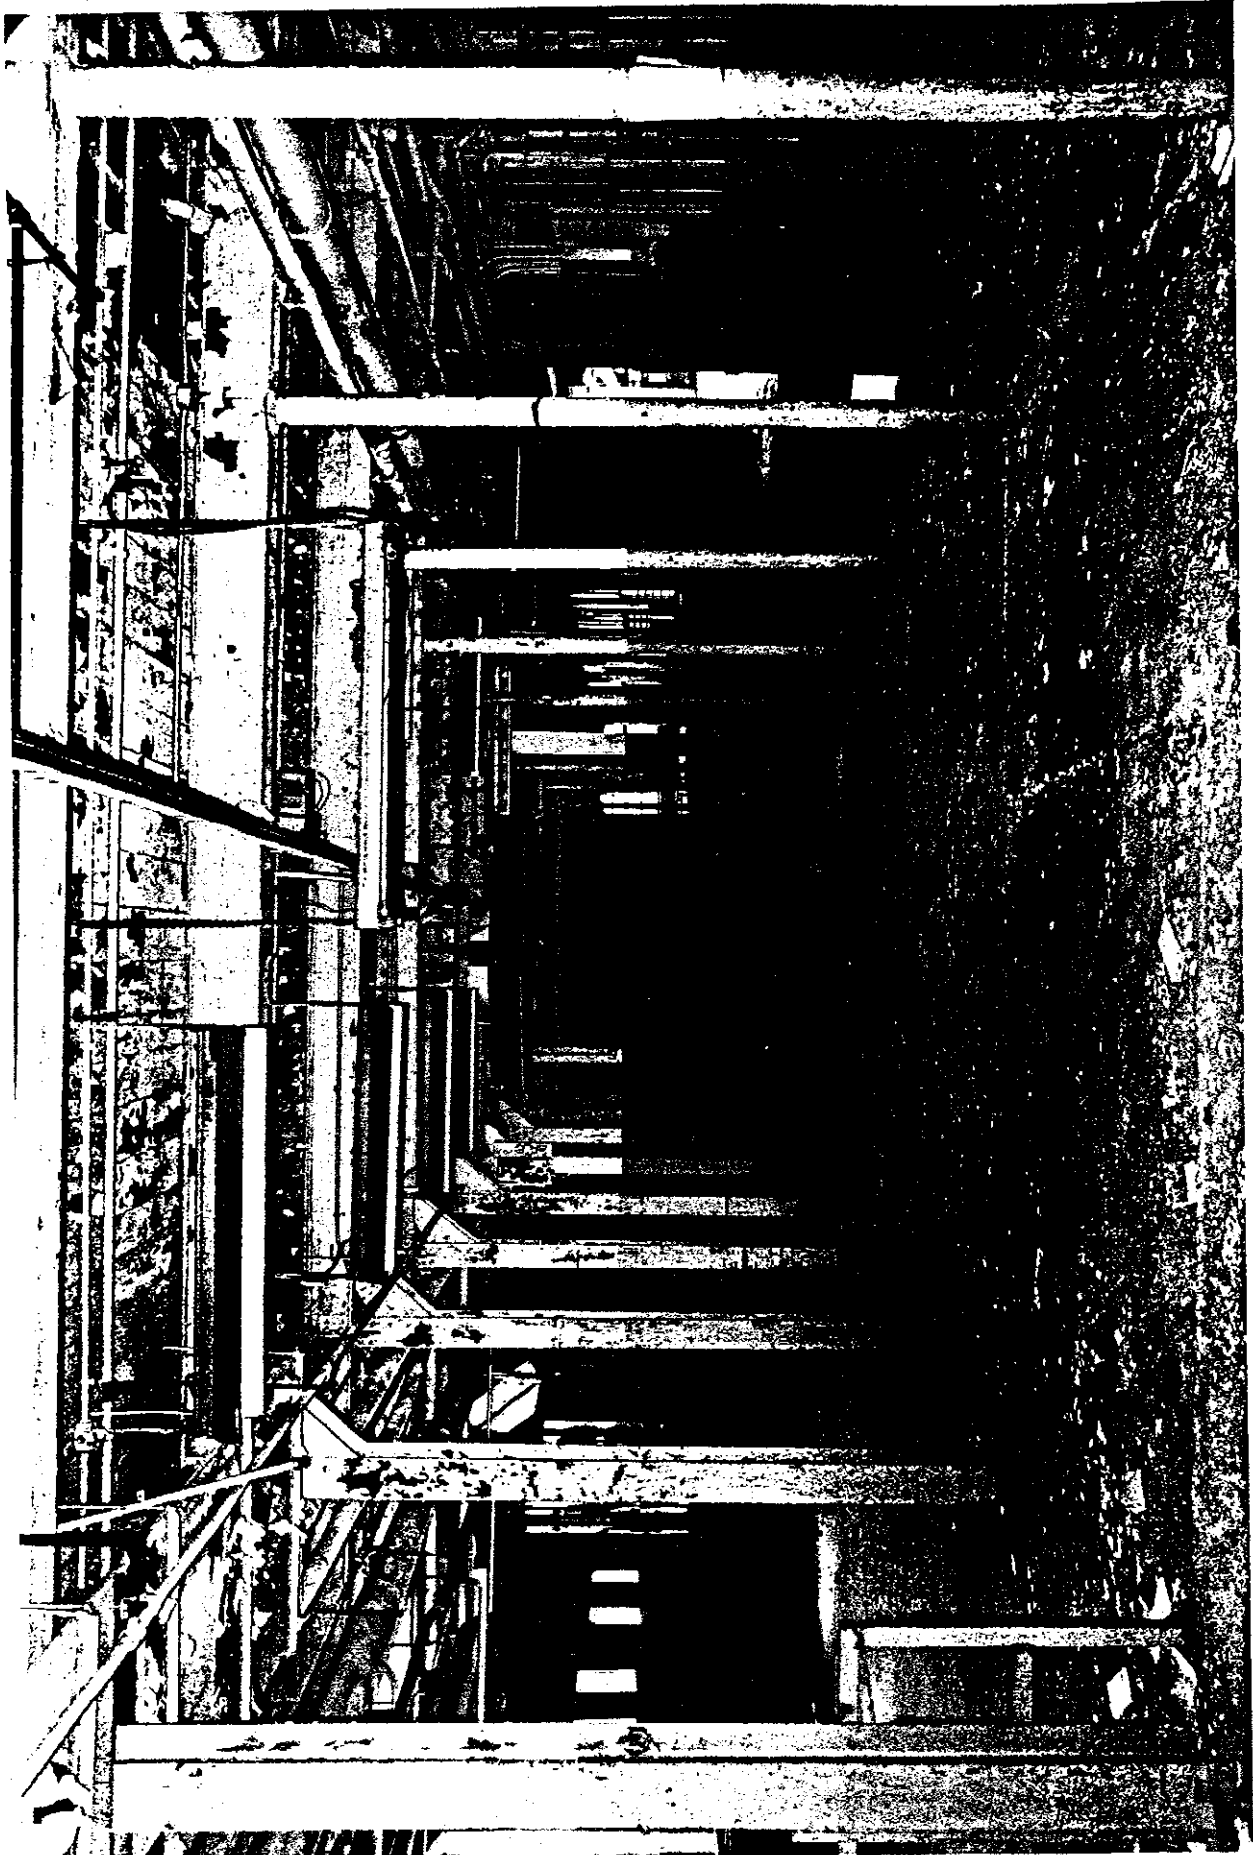
Typical interior for plant #28, 1st floor view S
